Clear Pointe Pond Water Quality Assessment Report

Lynch Station Va.

**Prepared by
Ben Tumolo, Nolan Compton – Environmental Science Students
Thomas D. Shahady, Ph.D.
Lynchburg College
May 31, 2013**

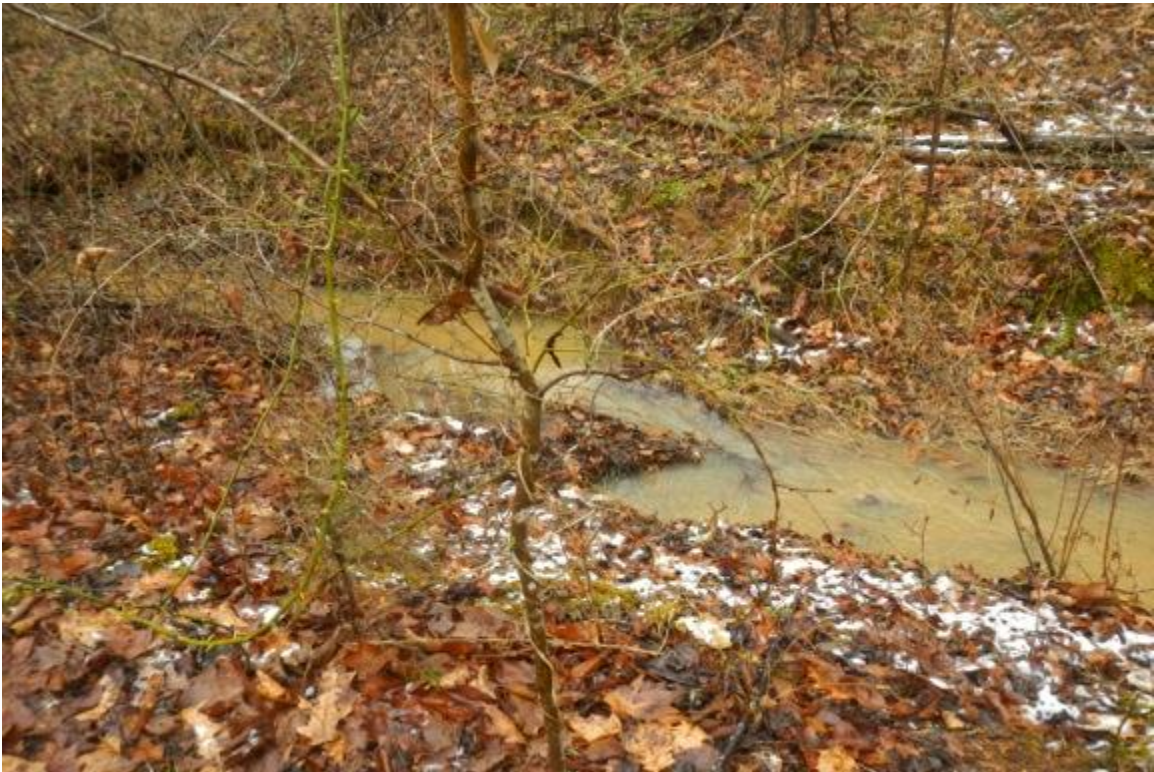
Tributary #1 is identified as the tributary furthest from the pond as seen entering into the main channel (Tributary #3) from the left as you walk up from the end of the pond. This tributary is very shallow and narrow and appeared ephemeral at the time of sampling. Considerable flow only occurs during storm events. Also, this tributary is part of the drainage system associated with the road system put in with this development. This tributary contained a considerable amount of leaf and stick litter within its channel. This material should flow into the pond during storm events. This tributary runs under the road through a man made concrete pipe before it enters Tributary #3 (Figure 2).

Figure 2: Tributary #1 flowing during one inch storm event. Note considerable turbidity in the water.

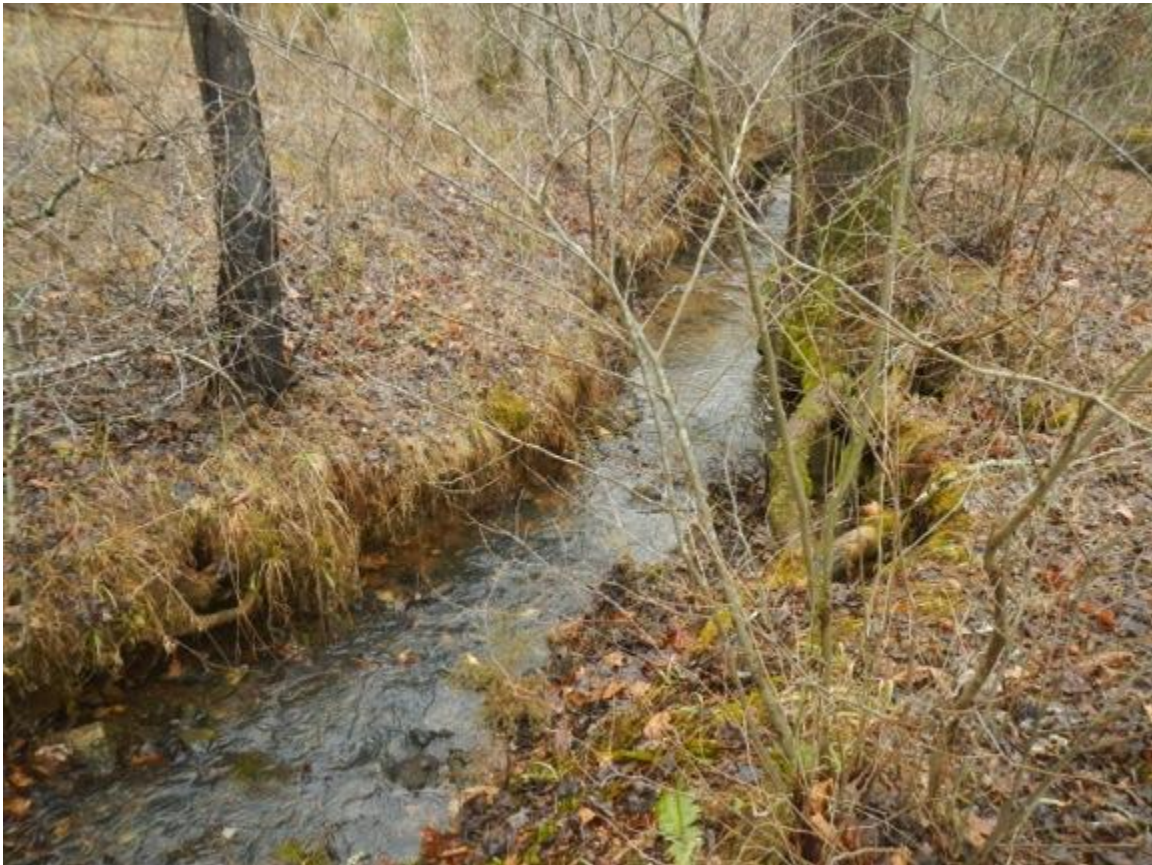
Tributary #2 is identified as the tributary flowing to form Tributary #3 from the right as you walk upstream from the pond. Tributary #2 contained water draining from the roadways and driveways and roadside grass (Figure 3). The portion of the watershed draining into Tributary 2 is the most developed area in this watershed.

Figure 3: Water flowing during one inch storm event in Tributary #2. Note the significantly eroded banks entrenching of the stream due to expansion of the stream from prior development. This is an ongoing concern.

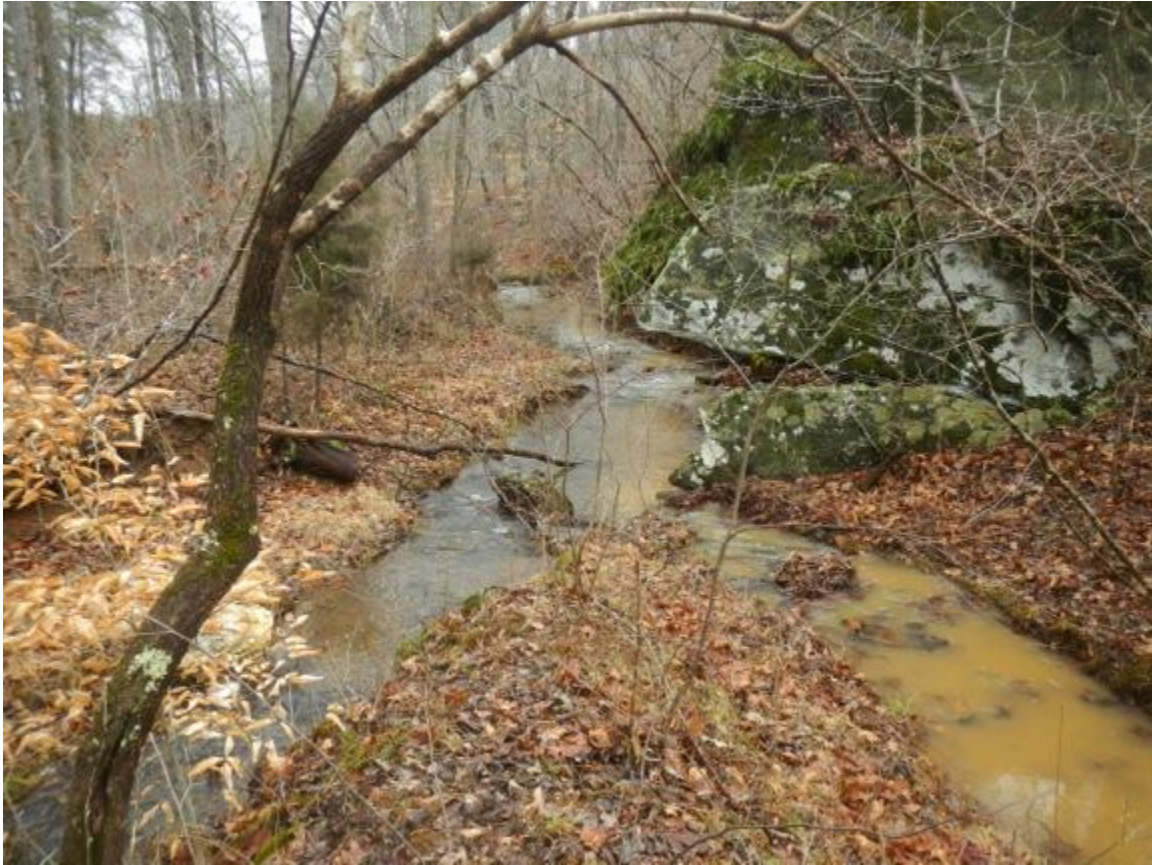
Figure 4: Water flowing into Tributary #3 during one inch storm at the confluence of Tributary #1 and #2. Note the contrast in turbidity between Tributary #1 (right portion of the figure) and Tributary #2.

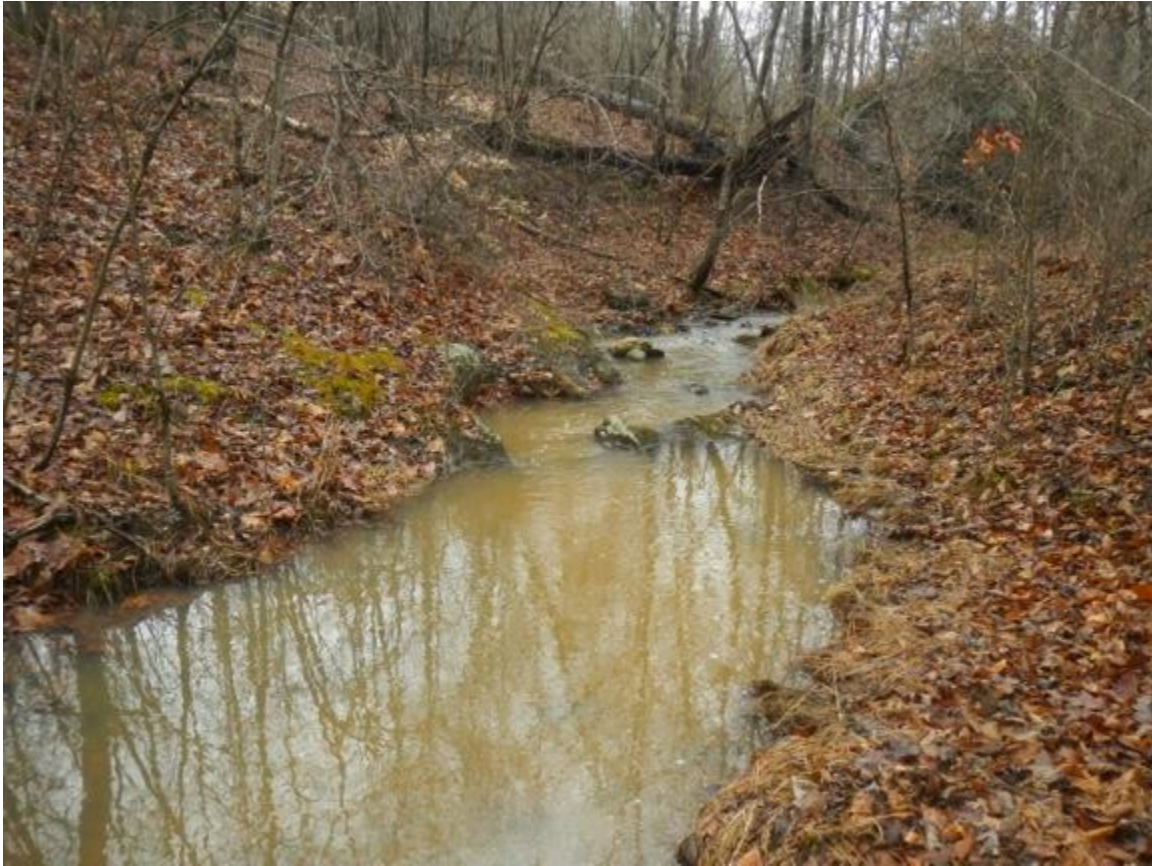
Tributary #3 is identified as the main tributary resulting from combination of Tributary #1 and #2. This tributary drains through forested watershed before entering the pond. Tributary #1 contributes a much higher sediment load than Tributary #2 during a storm event (Figure 4). Additionally this creates general turbid conditions throughout Tributary #3 (Figure 5).

Figure 5: Water flowing through Tributary #3 after one inch storm event near entrance to the pond. Note turbidity levels.

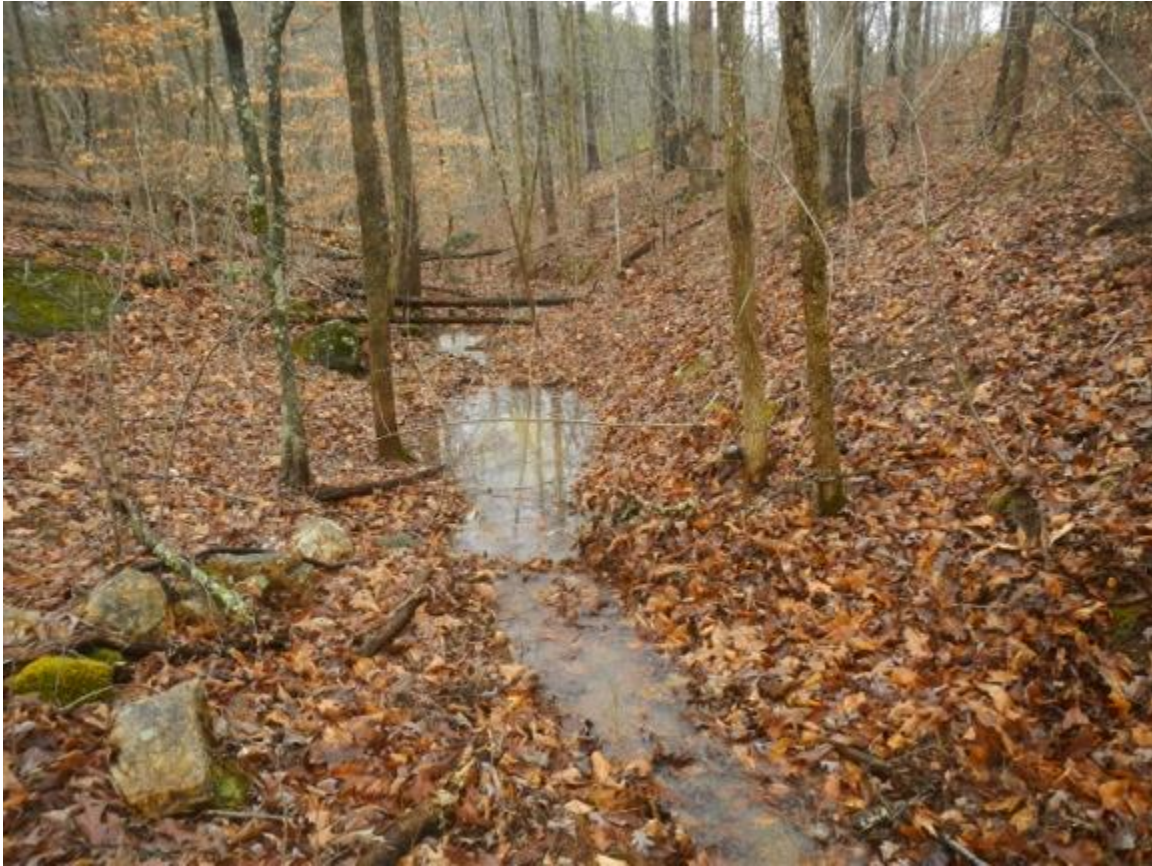
Tributary #4 is ephemeral and had minimal flow during the assessment. The channel was filled with leaf litter and plant material (Figure 6). This channel is predominantly forested however may contribute organic material from leaf litter during storm events. It is very shallow due to limited development in the watershed. These types of channels easily erode from development and can add significant amounts of sediment to a pond.

Figure 6: Heavy leaf litter as the defining characteristic feature of Tributary #4. Channel is ephemeral and note the lack of incision of stream channel due to low flow. Also have low levels of turbidity relative to a disturbed channel.

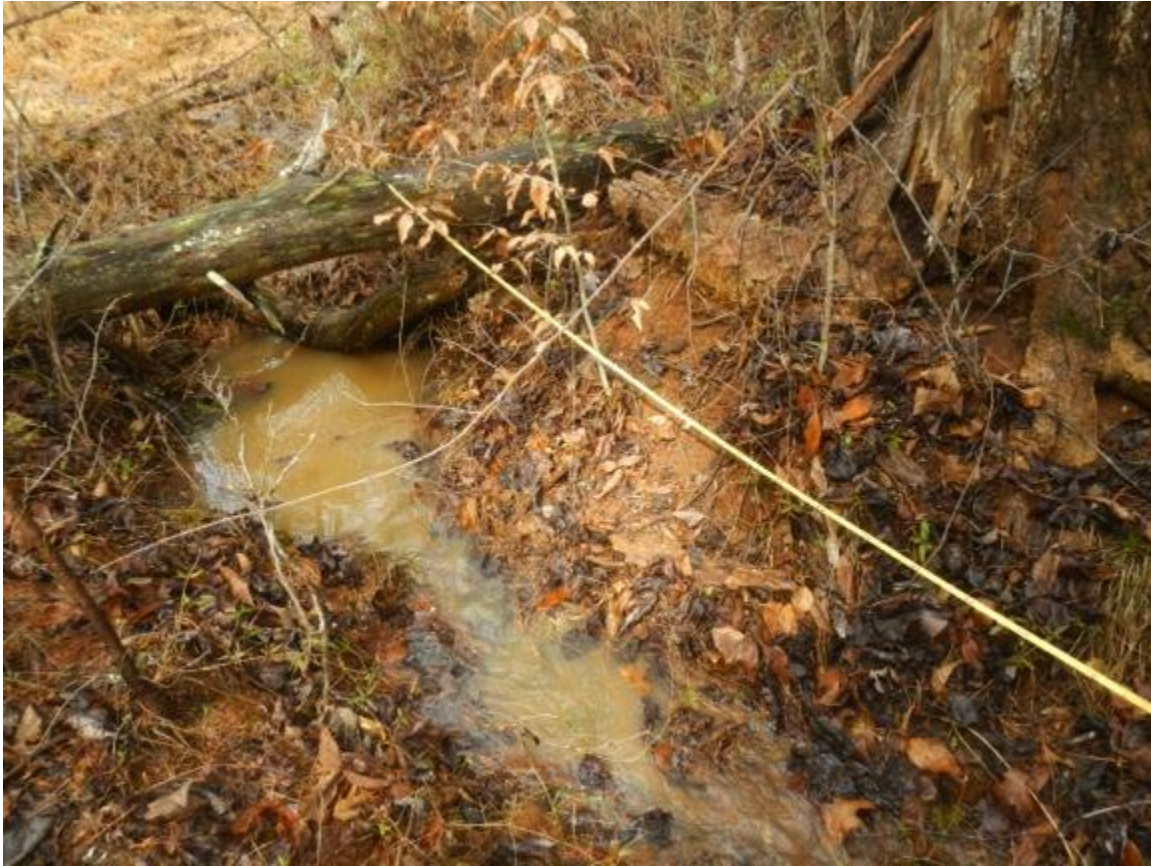
Tributary #5 is a very small ephemeral stream channel (Figure 7). During the assessment the stream contained very high turbidity and it was noted that stream banks were relatively unstable from erosion. This tributary receives stormwater from impervious surface and culverts creating increased flows and channelization. This channel is exhibiting the characteristics of a ephemeral channel impacted by development.

Figure 7. Tributary #5 during the storm event. Note the high turbidity and channelized stream banks.

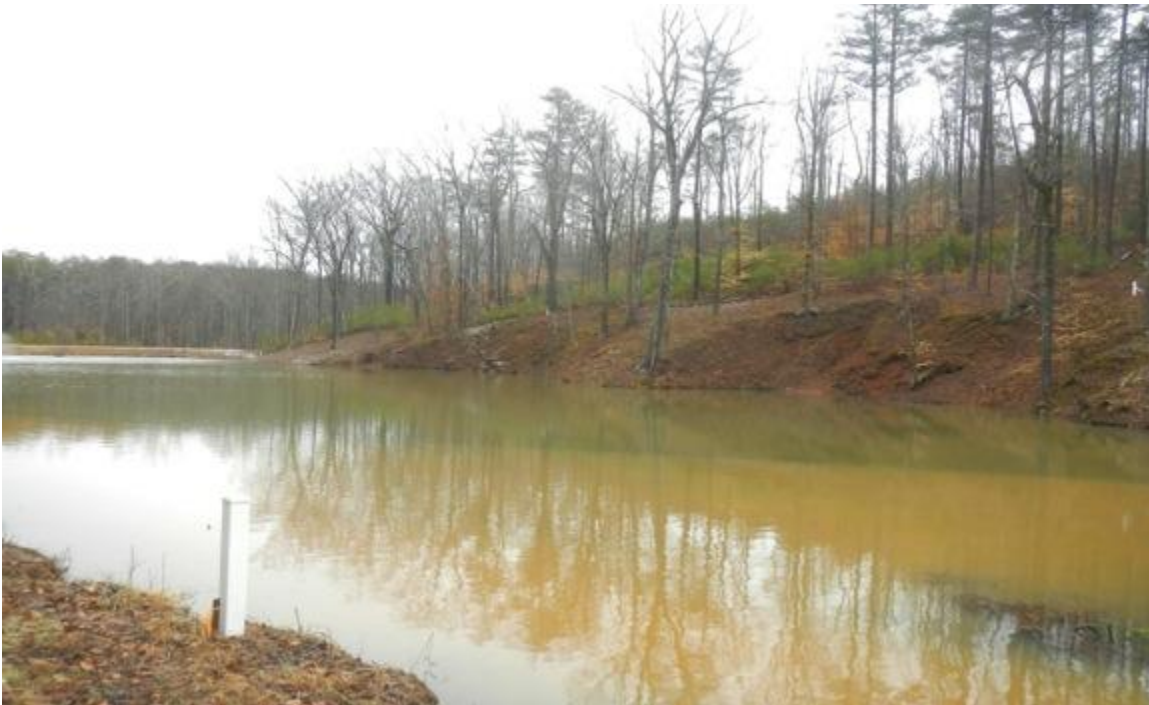
The pond did show visual evidence of sediment turbidity entering the lake during a storm event at the time of assessment (Figure 8). This occurs in the area of confluence between the lake and Tributary #3.

Figure 8 – Visual conditions of Clear Point Pond during a one inch storm event from March 2013. Note the visible sediment plume entering the lake.

The best option is to create a wetland in the area where tributary 3 enters the pond. Wetlands will control and metabolize a portion of the sediment and nutrients entering the pond and enhance water quality. Wetlands also enhance aquatic life in the pond. By mapping the potential area for the wetland creation and providing proper hydrology a wetland can be planted and managed. Plant selection is very important as cattails and water lilies should be avoided in this wetland as they can move into the pond creating problems. We have been successful in creating wetlands in this area and can further guidance for wetland creation.

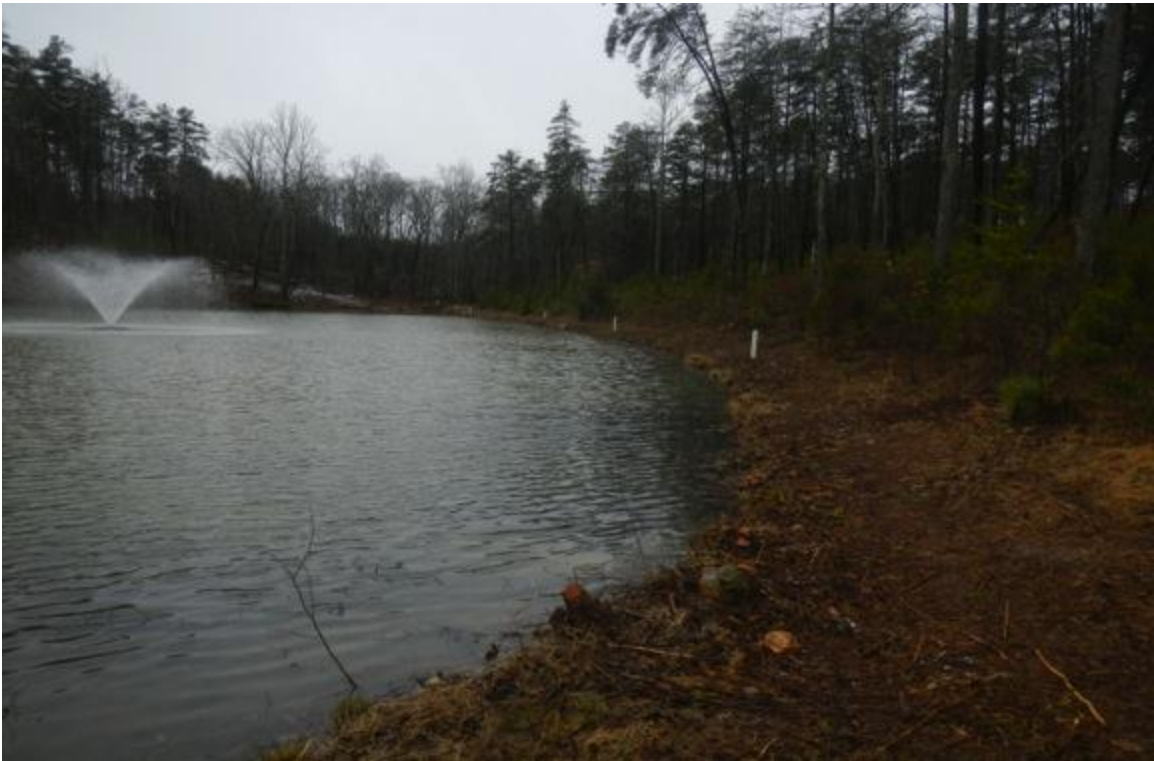
The perimeter of the lake is well maintained and at the time of assessment did not have and vegetation growing directly on the perimeter. By evidence of stumps it appeared alders and other woody vegetation within one meter of the littoral zone were removed. This is a good practice maintain good shoreline and keep excess organic material from entering the pond.

Figure 9 - Littoral zone of the lake including alder and woody vegetation removal.

Vegetation Control – Any excessive growth of vegetation on dam or shoreline should continue to be removed and prevented. Once roots are established, they destroy the integrity of the dam and create leaks and other structural problems. Currently the pond is in good condition and this should be maintained. We did not observe any excessive aquatic weed growth in the pond. This should be closely monitored every year.

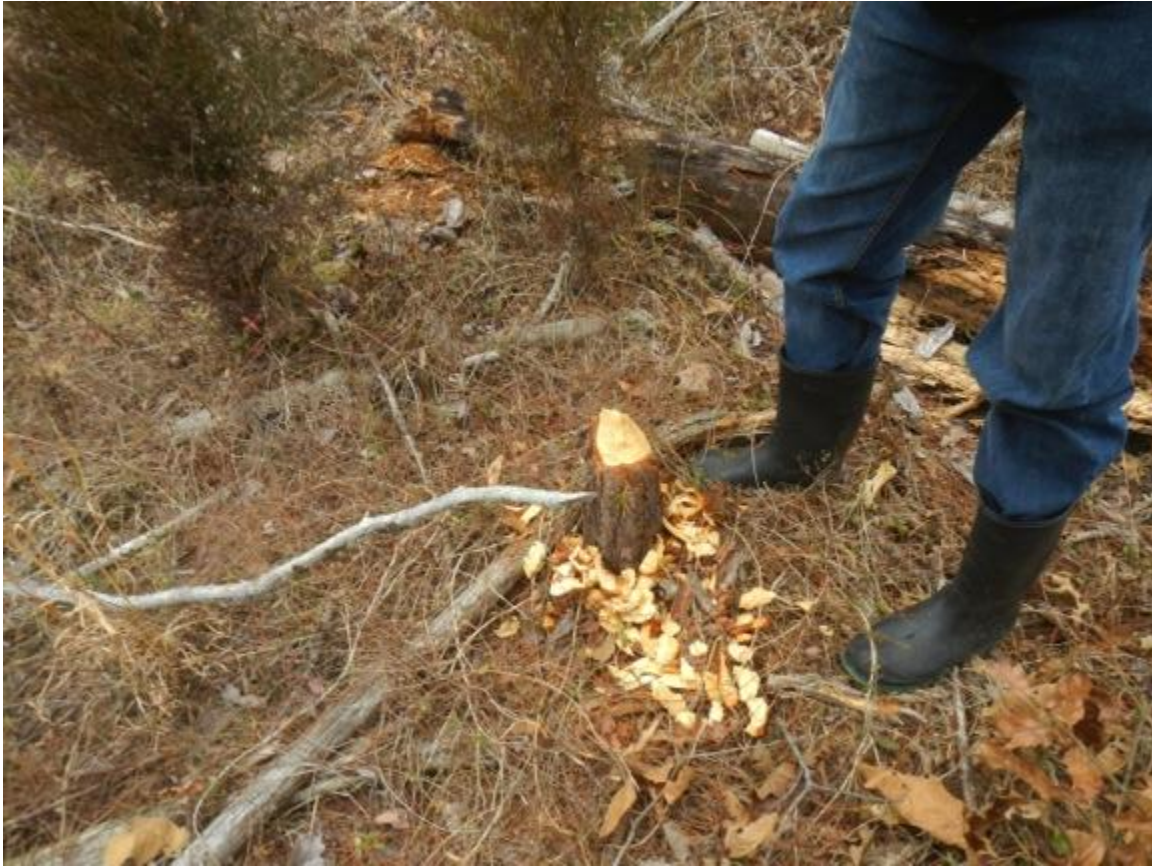
Other observed characteristics of the pond included some beaver activity (Figure 10). Beavers are important to manage as this species can cause damage to the pond. Specific recommendations are given in management section of this report.

Figure 10: Observed beaver activity along the perimeter of the pond. Note this is recent activity suggesting a current pair of beavers occupies the pond.

include removal of vegetation around the pond, building of lodge, manipulation of water levels (to acquire new vegetation) and building of dams upstream. We recommend removing beavers from the pond. You can hire a wildlife removal expert or remove the beavers yourself. They are nocturnal so it is often easier to trap them than shoot a beaver. A permit is required. It is important to remove the female as only removing the male simply makes room for a new male to inhabit the pond.

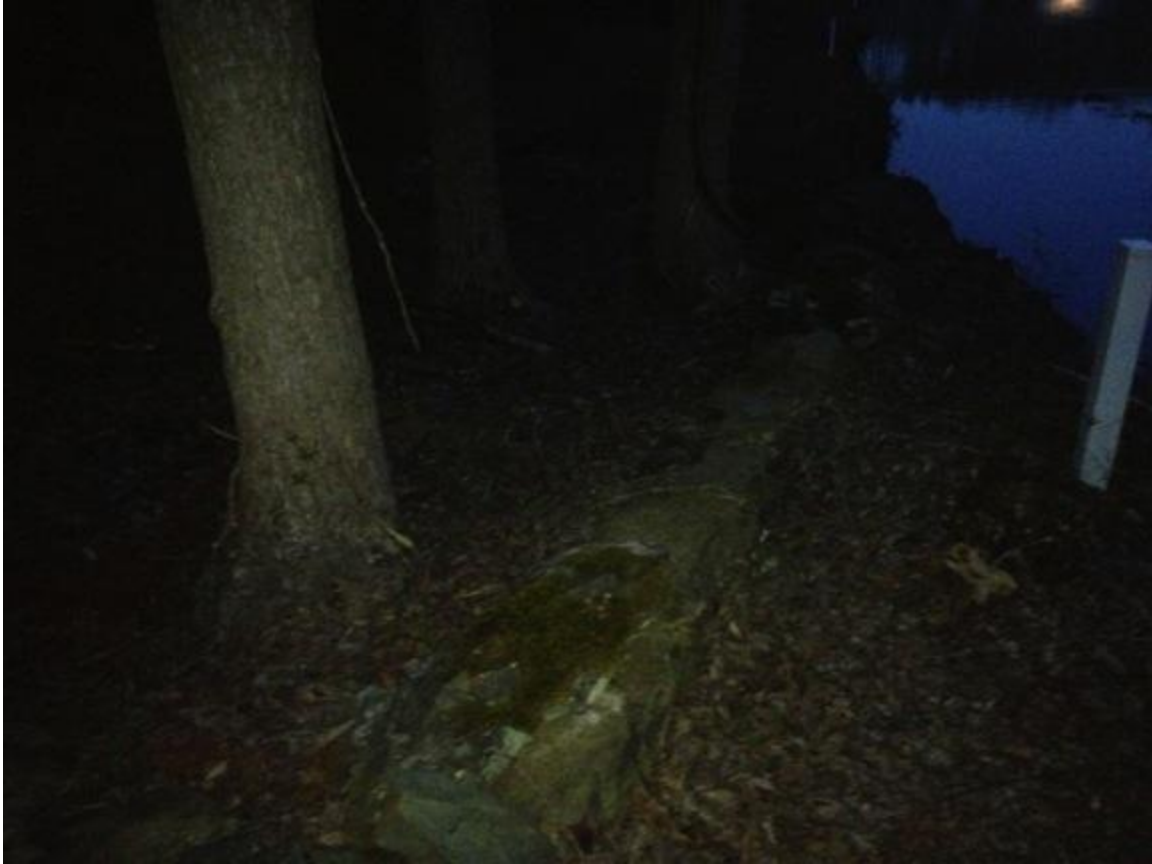
Along the upper portion of the pond a stone foundation was detected (Figure 11). It is important to understand any historical significance of this foundation as certain laws and restrictions may apply to any disturbance of this structure as future development of the pond occurs. We would suggest research to document the significance of the structure.

Figure 11: The remains of a stone foundation along the upper perimeter of the pond. Historical significance is unknown.

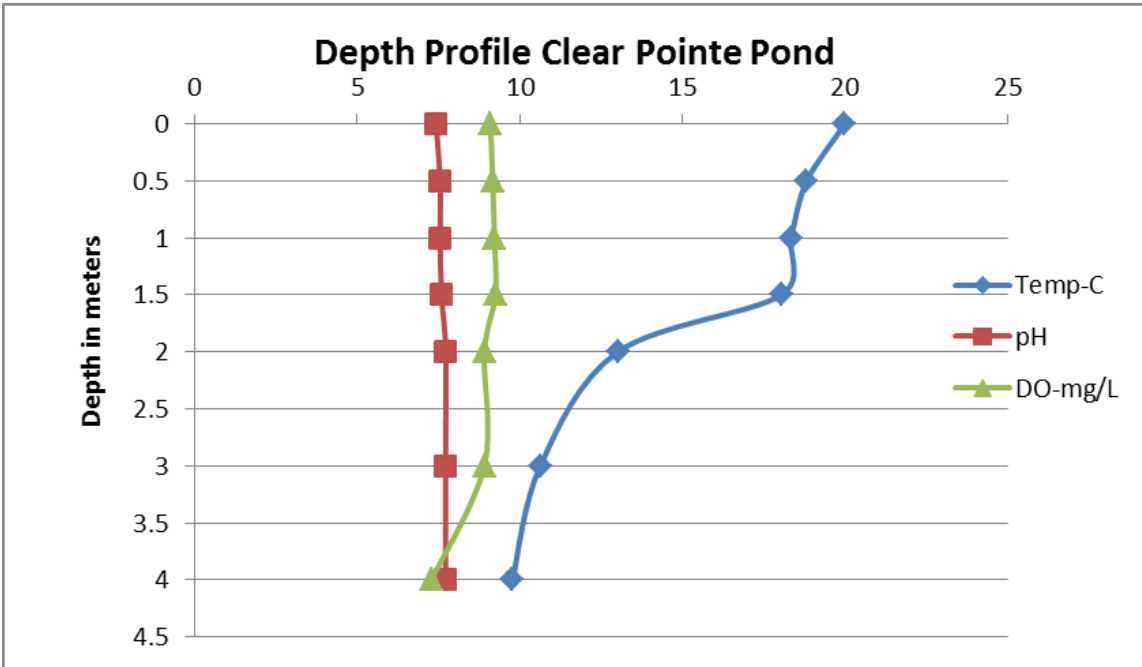
Our assessment demonstrated the pond does stratify (Figure 13). This is typical for a pond of this size and depth. The pond does have excellent depth at the dam and all effort should be taken to maintain this good depth. Relatively high chlorophyll *a* concentrations (Table 3) suggest the pond is experiencing some eutrophication and this is a concern. But Secchi depth is good and demonstrates the pond still has excellent water clarity. Oxygen and pH were at consistent measures from surface through depth. This is likely a result of the fountain and early spring conditions. Continued operation of the fountain is suggested.

Figure 13: Lake profile developed using the hydrolab on April 16th 2013 at the site near the dam. Note the stratification of the pond (temperature) but relative even distribution of pH and oxygen with depth.
