Clear Pointe Pond Water Quality Assessment Report

Lynch Station Va.

**Prepared by
Ben Tumolo, Nolan Compton – Environmental Science Students
Thomas D. Shahady, Ph.D.
Lynchburg College
May 31, 2013**

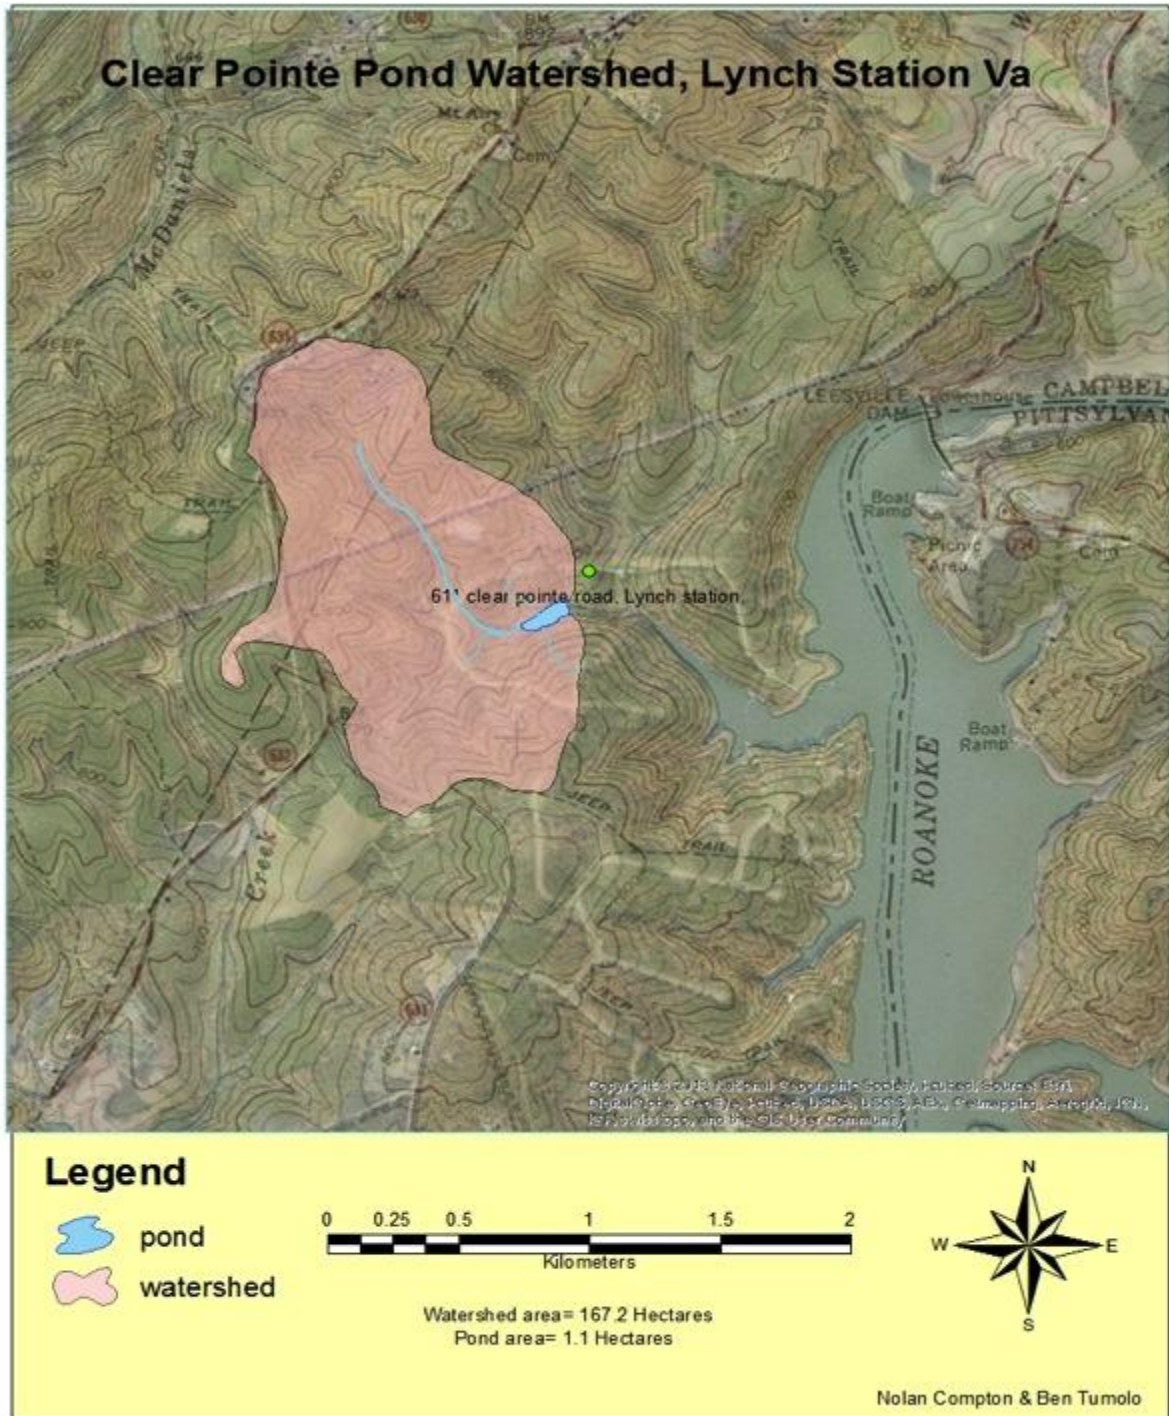
Watershed is primarily wooded. Roads and driveways of a new sub-development are present and property lines exist for future development. We created GIS maps to delineate the watershed (Figure 1) and provide watershed boundaries to better assess effects of development on the pond.

Figure 1: Watershed map of Clear Pointe Pond located in Lynch Station Virginia. The pond is located on a tributary to Leesville Lake. We acknowledge help of Dr. Dave Perault , Professor of Environmental Science for assistance in creating this map.
